Sally Starbuck: Gaia Ecotecture

Gaia ecotecture

The Village project
Sustainable Projects
Ireland Ltd,

Cloughjordan, Co
Tipperary

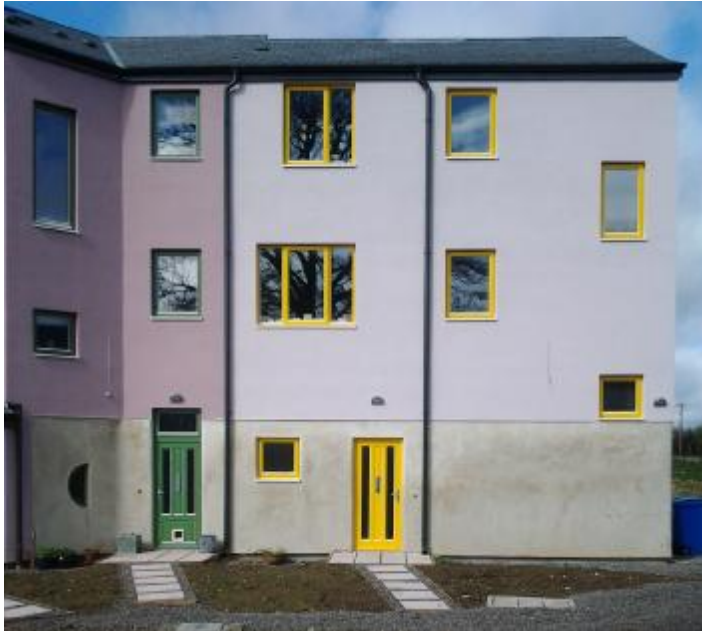
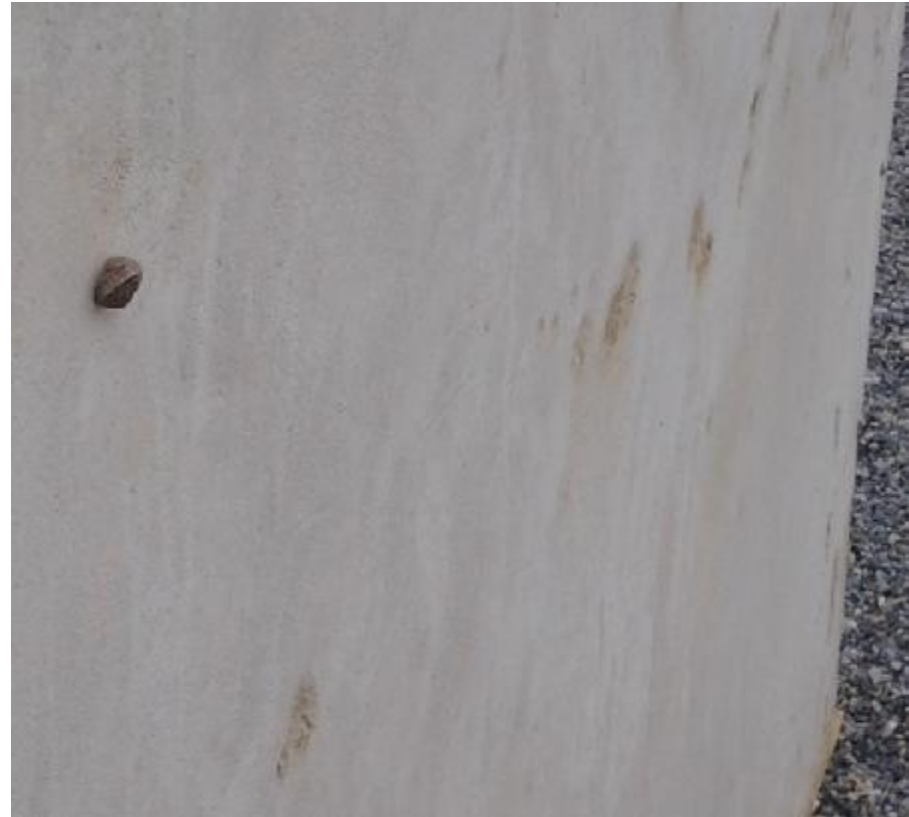
***East side more sheltered,
to be painted this Summer;
curing/ drying slower.....***

***@ end Aug. darker still 34% MC within 15mm of
surface on the N & NW-facing (most sheltered) walls.
West side, dry, white and friable before rendering.***

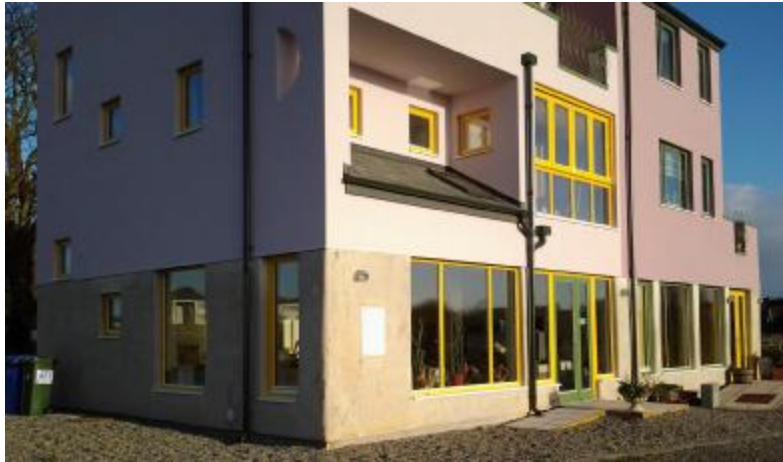
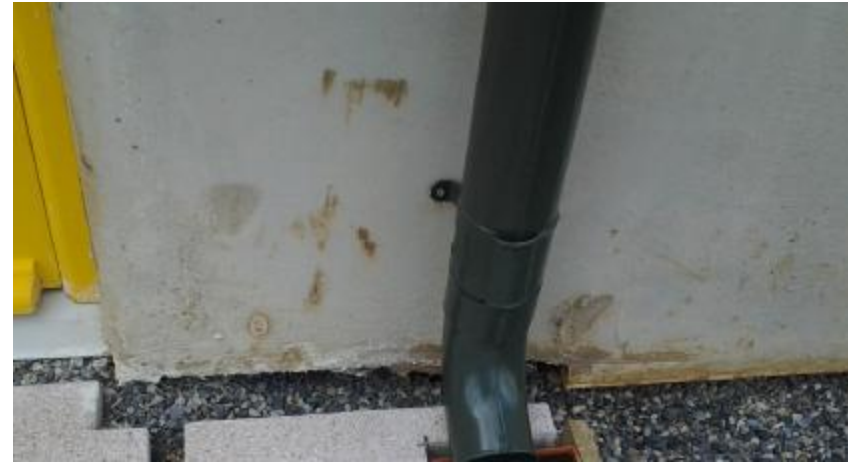
North and west facades – exposed,

Deterioration with splashback off gravel surfaces (level to be reduced)

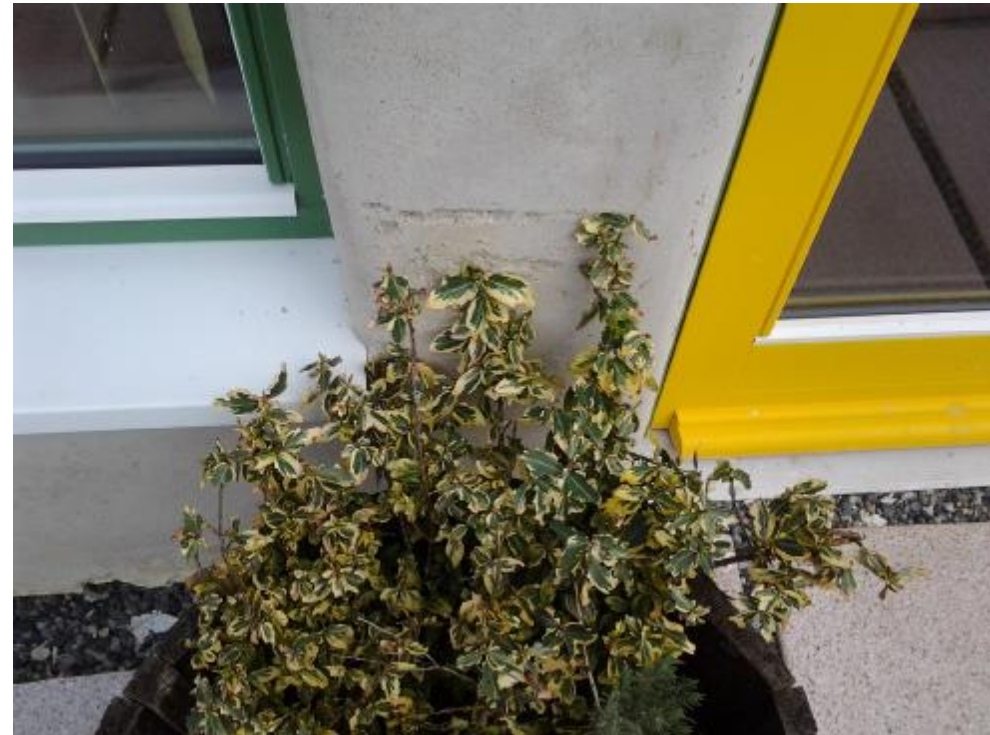
West side - exposed

surface scratched by Holly

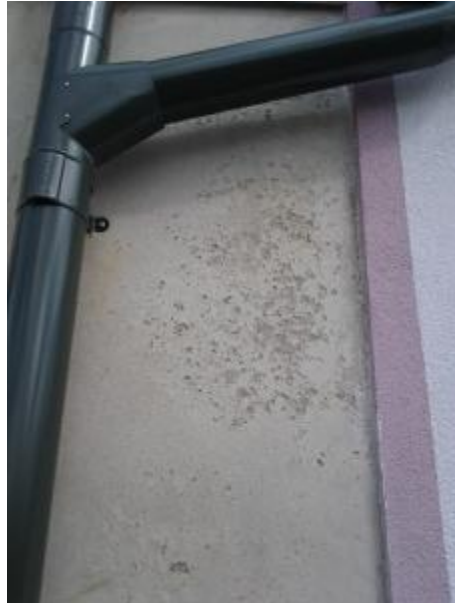
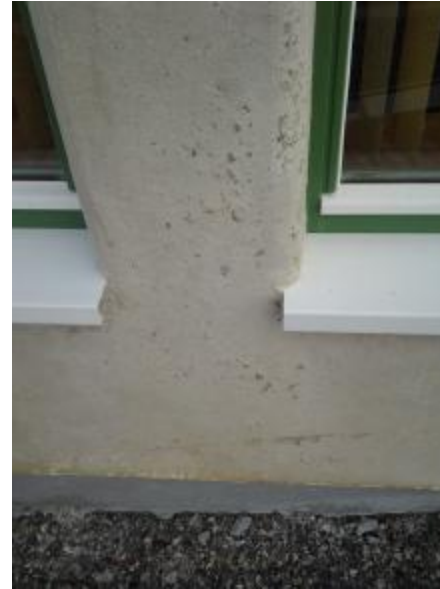
West side - exposed

surface damaged by hail stones

*To be rubbed-up again in better weather ,
then painted this Summer;*

- To allow everything to be well carbonated
before the Keim is applied... Charcoal colour TBC*

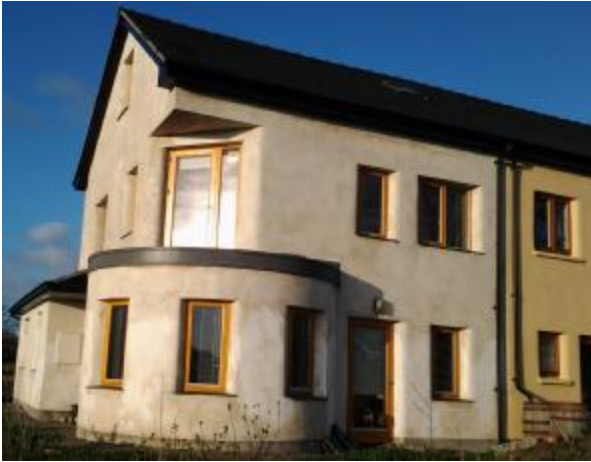
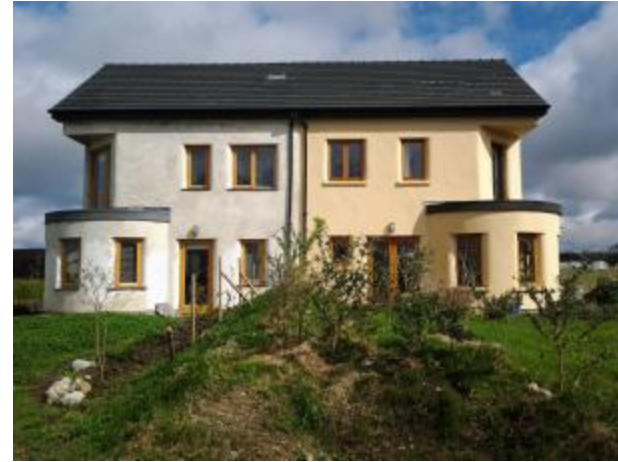
i) Semi-detached site facing south:

*West side, timber frame with
hemplime render [needing limewash!]*

East side, hemplime walling...

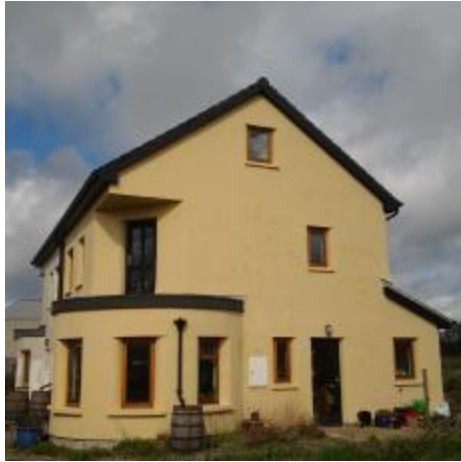
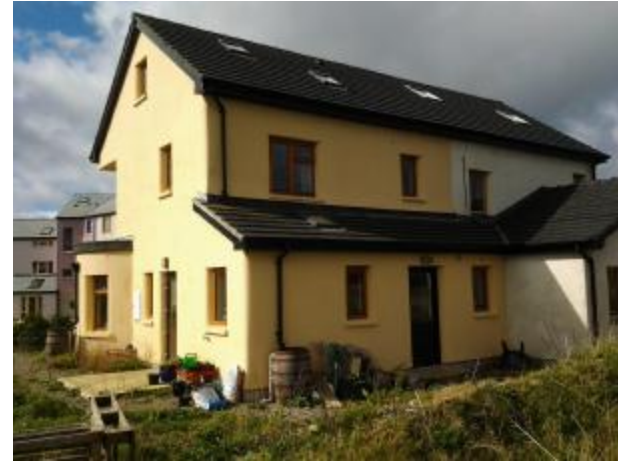
*i) East façade relatively sheltered.
Outside painted at end of summer,
in best condition on most exposed
facades*

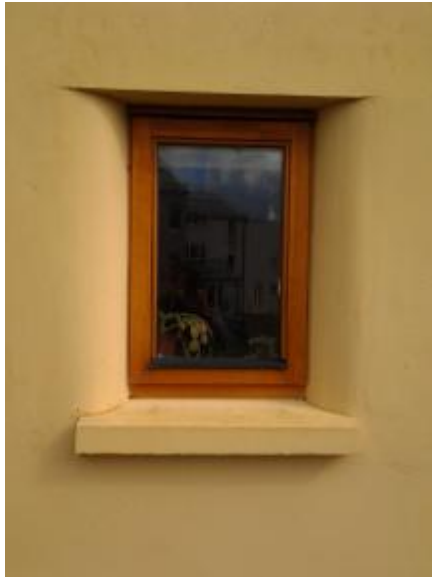
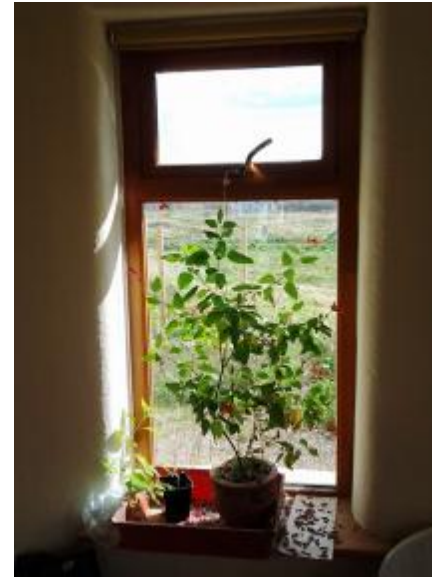
i) Clay hemp mix internal plaster on permanent shuttering, some peeling where painted too quickly inside.

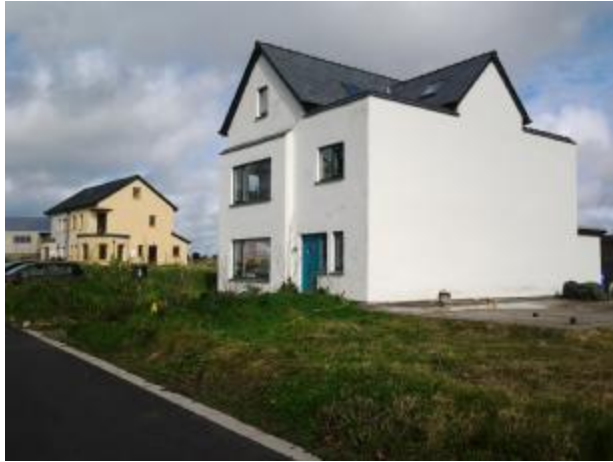
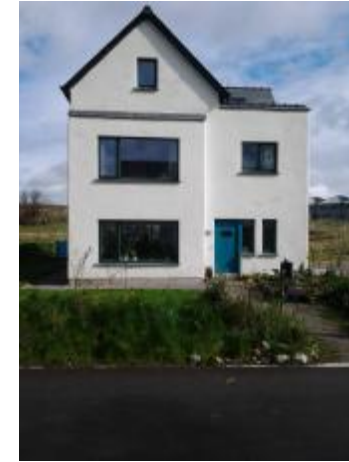
*ii) Hemplime walling to 3 storey house
Mix wetted too much but not well-compacted either;
huge shrinkage at all interfaces
Wallplate left exposed by ~ 100mm.
Poor airtightness performance for MVHR*

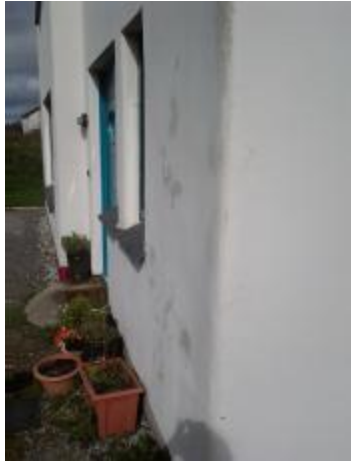
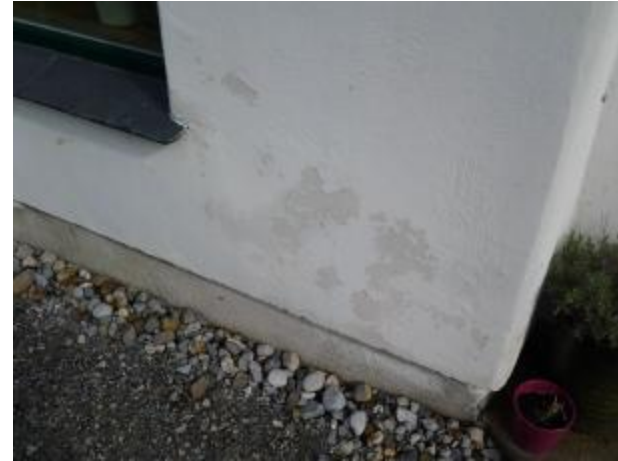
*ii) Hemplime walling
Painted too soon?*

*[Other Lime Cob hemp render mixes' problems with
mineral stains need a good breathable paint.]*

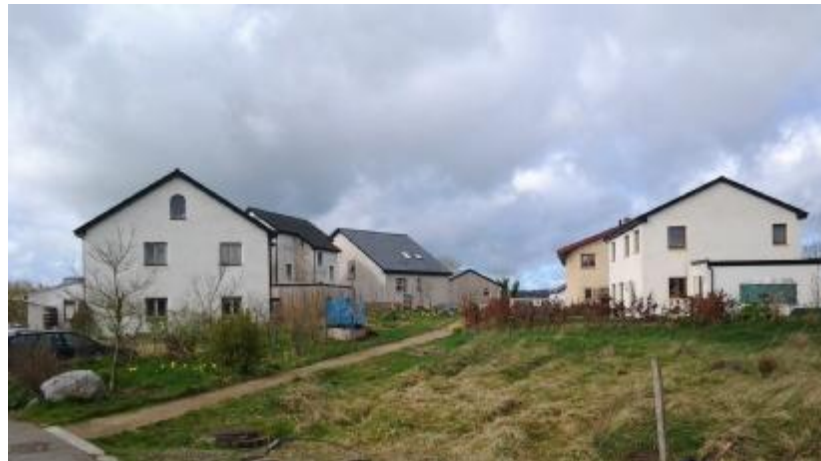
*[iv) Neighbour was cast too quickly so
mineral leaching a problem]*
