Sally Starbuck: Gaia Ecotecture

Gaia ecotecture

The Village project
Sustainable Projects
Ireland Ltd,

Cloughjordan, Co
Tipperary

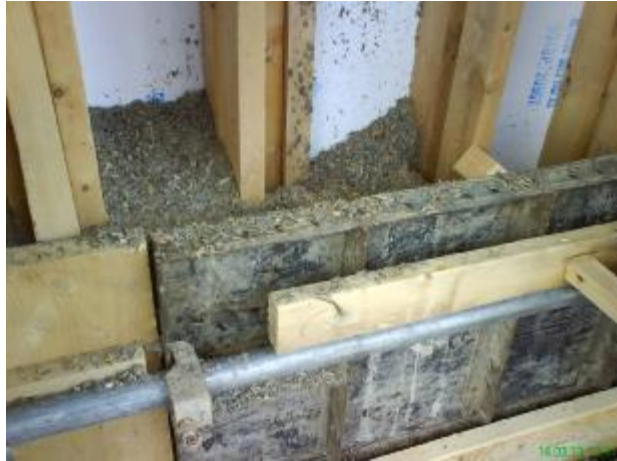
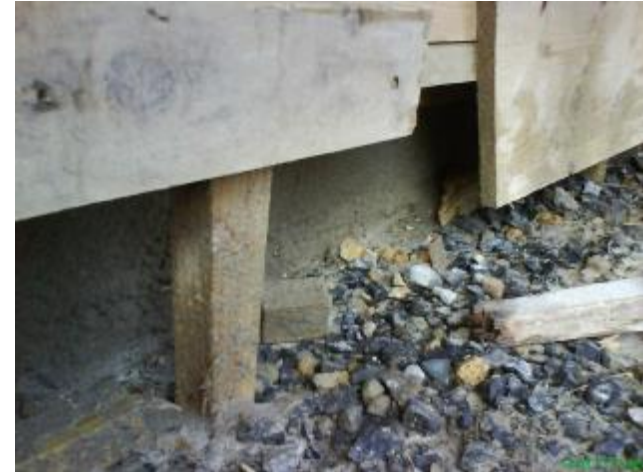
Casting Hemp-limecrete, Mar.'13

“ Hemp-limecrete wall infill is not affected detrimentally by frosty conditions during curing

(< 5 degrees C & -5 overnight):

- Material will remain firm, solid & surface dry by the wind.*
- Low temperatures will not affect the resistive integrity of the material.*
- The inner core will be as the day it was cast, unchanged.*
- Tap surface to test the walling has not suffered damage.”*

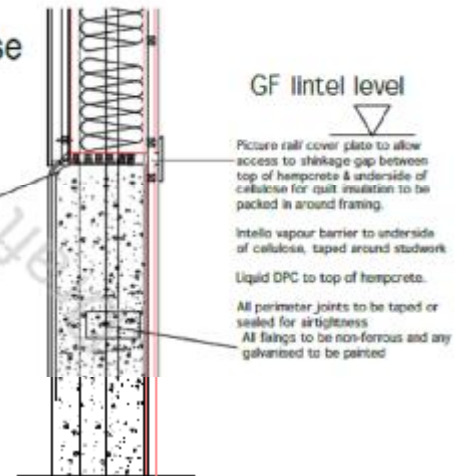
Hemp-lime to cellulose wall insulation detail

All perimeter joints to be taped or sealed for airtightness.
Corner webbing bedded in render, cast or cut to chamfer (extending to reveals also).
Generic frame seal bead at junction with ext. render for waterproofing

Structural ope cut in June to template of window frame.

“At DPC level expanded metal lath or a trowel full of scratch hemplime plaster would solve any rigidity issues and is very little extra work.

Top of the hemplime wall at interface with the cellulose:

- *2-3 mm of ordinary hydrated lime as an interface desiccant & sterilant or vermiculite.*

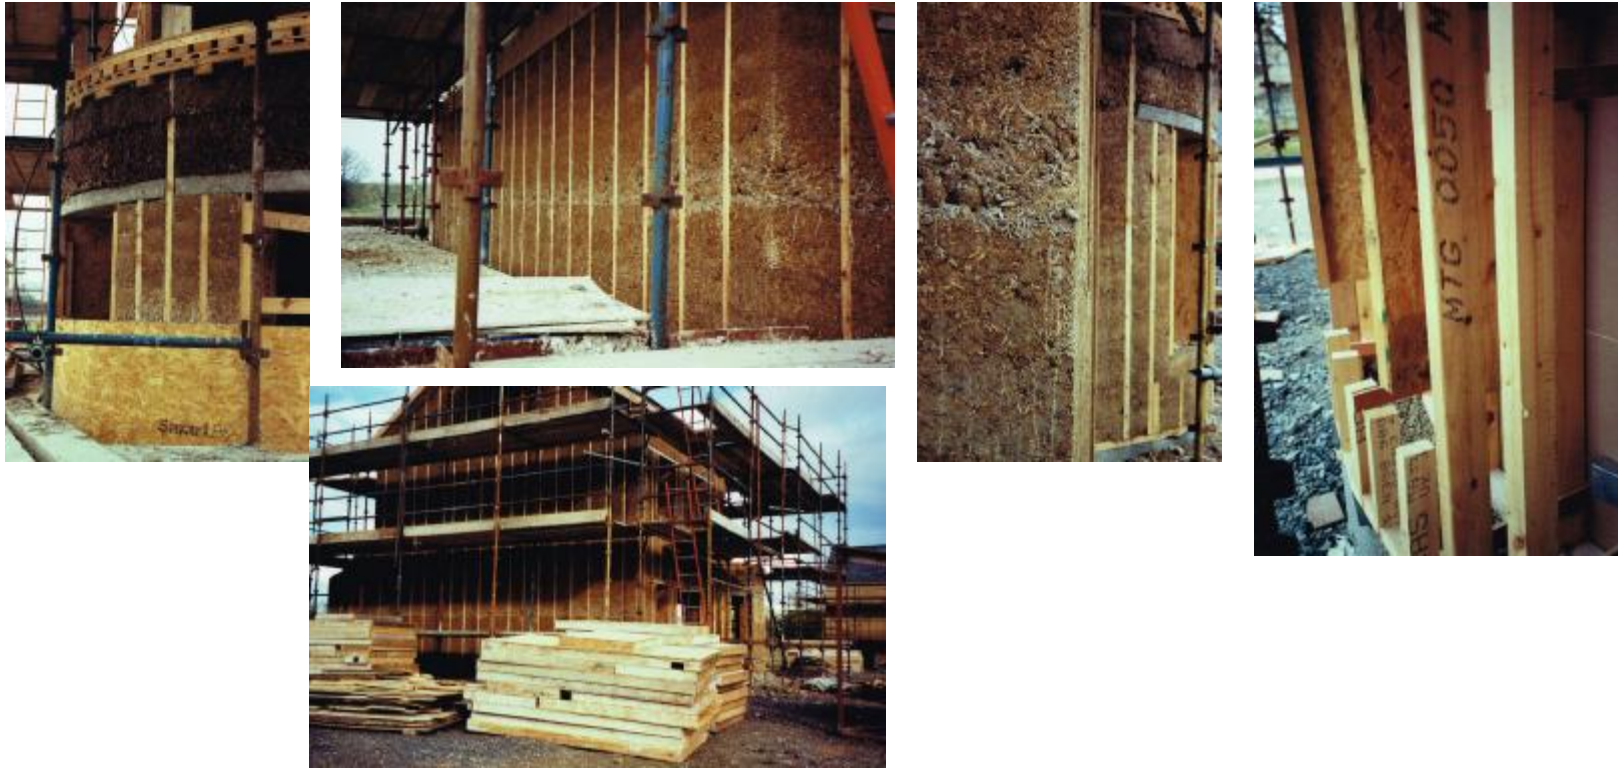
- i) Casting of hemplime walling with electrical conduit
cast in on permanent shuttering....
successful... no mice, unlike nextdoor!*

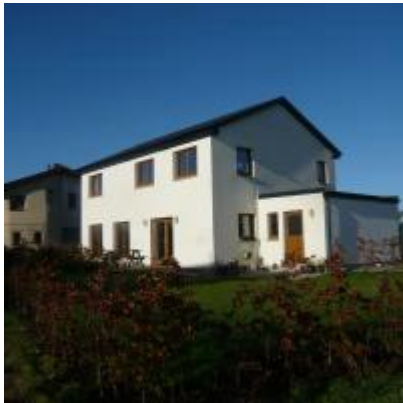
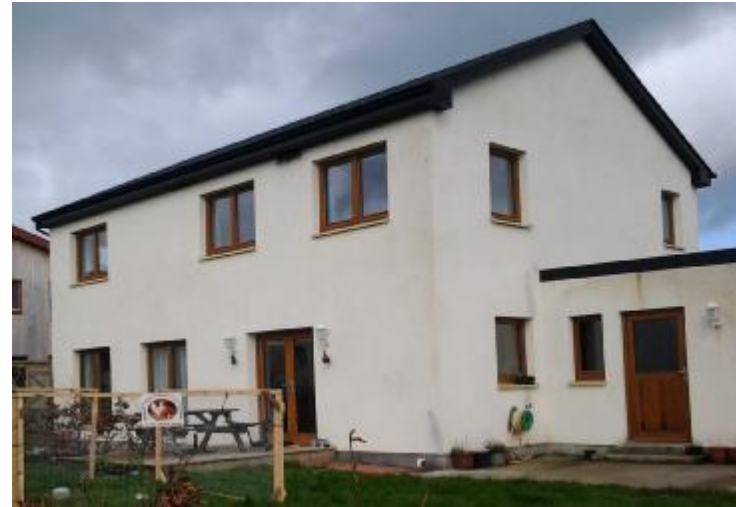
ii) Detached house, 2 storey, 4 bedrooms, total floor area of 170m²

300mm thick hemcrete walls cast using lightweight plastic shuttering took 2 weeks to complete

U-Value 0.22 W/sqm.k

Air Tightness Test on the House achieved a value of 1.12m³(m².hr)

41.5 KW/hrs/m²/yr Delivered Energy

67.25 KW/hrs/m²/yr Primary energy

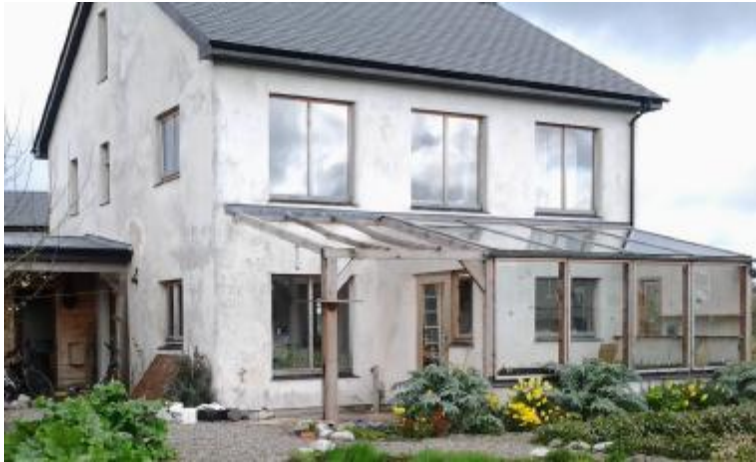
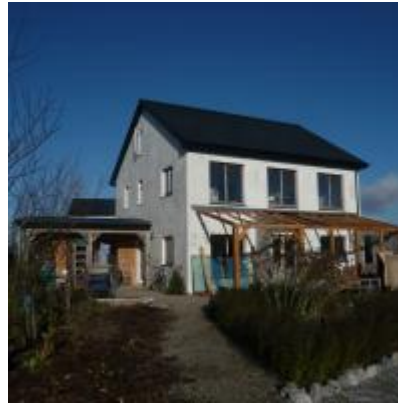
*iii) Timber frame with
hemp-limecrete, unpainted
Self built.*
